# BHP

## Moly-cop Comsteel Wheels PUBLIC RECORD VERSION

29 May 2018

# Introduction

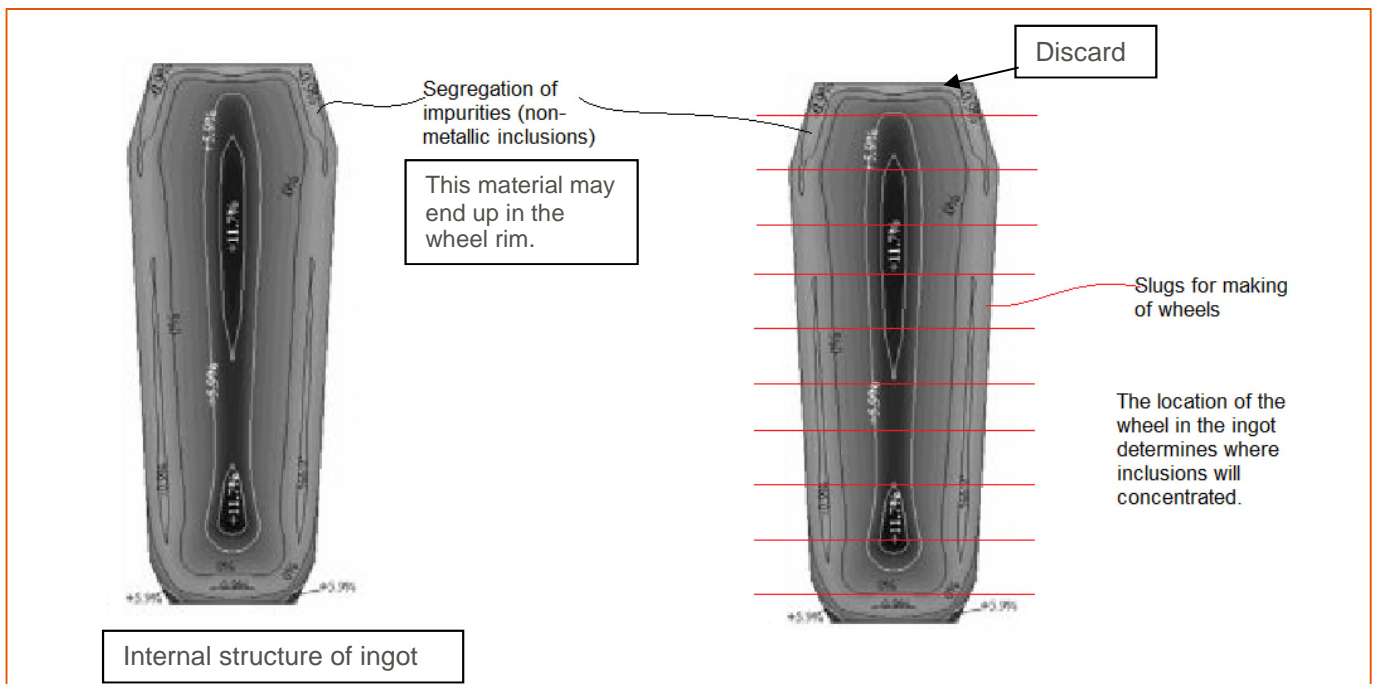
5 of the last 8 wheel cracks originated from subsurface defects. These occur when small inclusions in the steel grow through cyclic loading until they break out onto the tread and rim surfaces.

The presence of these inclusions is a result of the feedstock and manufacturing process employed by Moly-cop Comsteel (MC). MC melt down scrap steel and utilise an ingot casting method to manufacture the bloom used to forge the wheel. Scrap steel has inherent impurities present that are usually reduced in the bloom through dilution and treatment of the molten steel before casting. The ingot-casting process entails casting the molten steel into an ingot mould. The method of casting, the cleanliness of the steel and the control over the cooling process in the mould will determine how impurities are distributed through the ingot (segregation), Figure 1. The factors that will determine the quality of the wheels are the cleanliness of the steel poured into the ingot, the control over the solidification process and the amount of discard removed from the ends of the ingot. A high degree of care during the ingot casting process is required to ensure acceptable wheel quality.

Figure 1: Schematic of steel slugs for wheel forgings taken from ingot feedstock.
