**NATIONAL
RADIOACTIVE
WASTE MANAGEMENT
FACILITY**

Technical Report - Site Characterisation, Napandee

Client: Commonwealth Department of Industry, Innovation and Science

AECOM Australia Pty Ltd

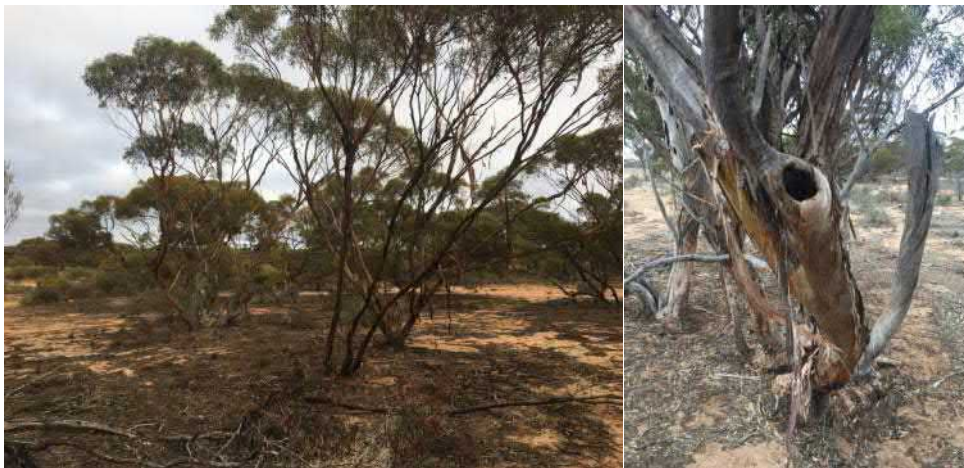
Mallee vegetation to the south west corner of the subject paddock

Whilst the centre of the paddock itself was devoid of habitat, the south-west corner of the paddock and its perimeter consisted of Mallee vegetation (referred to as A1 in Table 5). Mallee vegetation in the southwest corner of the paddock formed a block of vegetation approximately two and a half hectares in size and is included within the site footprint. This area of vegetation which aligns with vegetation code A1 was continuous with road side vegetation connecting to potential wildlife corridors to the north and east of the site. The area was dominated by tall, and in many cases, large old hollow bearing Mallee eucalypts. However, understorey was disturbed with prevalent bare ground and a sparse cover of saltbush and sedges. Grass cover and soil crust was sparse to absent. Habitat features of this area included the aforementioned tree hollows, peeling bark, large woody debris and logs (some of which contained hollows) and organic leaf litter with the area providing good opportunities for foraging and breeding birds and some habitat value for ground dwelling fauna such as reptiles and small mammals. Whilst not present in the paddock at the time, signs of past livestock access (sheep) were prevalent and grazing is likely to have compromised understorey diversity and thus habitat values.

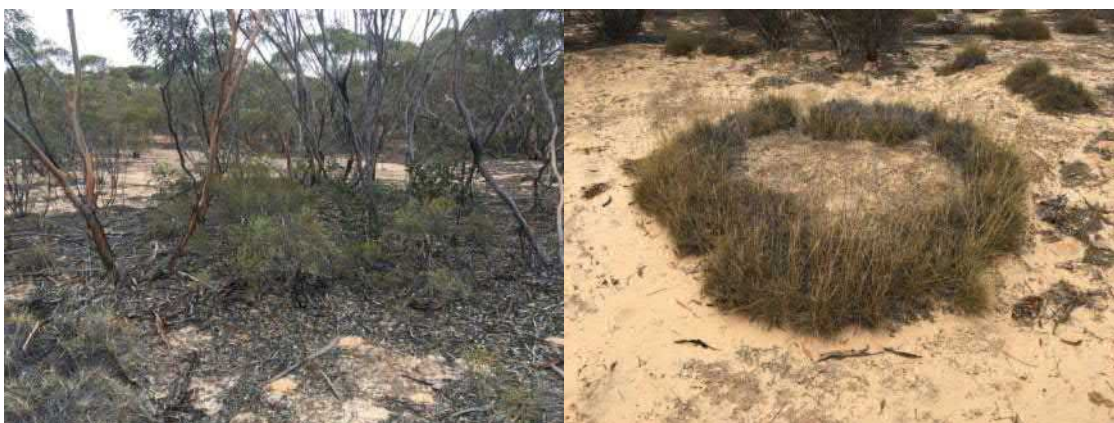
Intact Mallee vegetation showing shrub and spinifex cover

To the south of the site's boundary and along roadsides, vegetation was similar to that described above with minor differences. For instance, an assessment of vegetation to the south-west of the subject paddock and to the south of the intersection of Tola Road and Larwood Road, revealed a similar canopy cover but increased understorey diversity with soil crust and additional lifeforms such as the presence of spinifex grass and Broombush adding additional habitat complexity with an absence of grazing by livestock the likely cause of these differences. Whilst vegetation lining the boundary of the site was typically more disturbed with these thin linear areas often completely devoid of understorey lifeforms and habitat complexities.

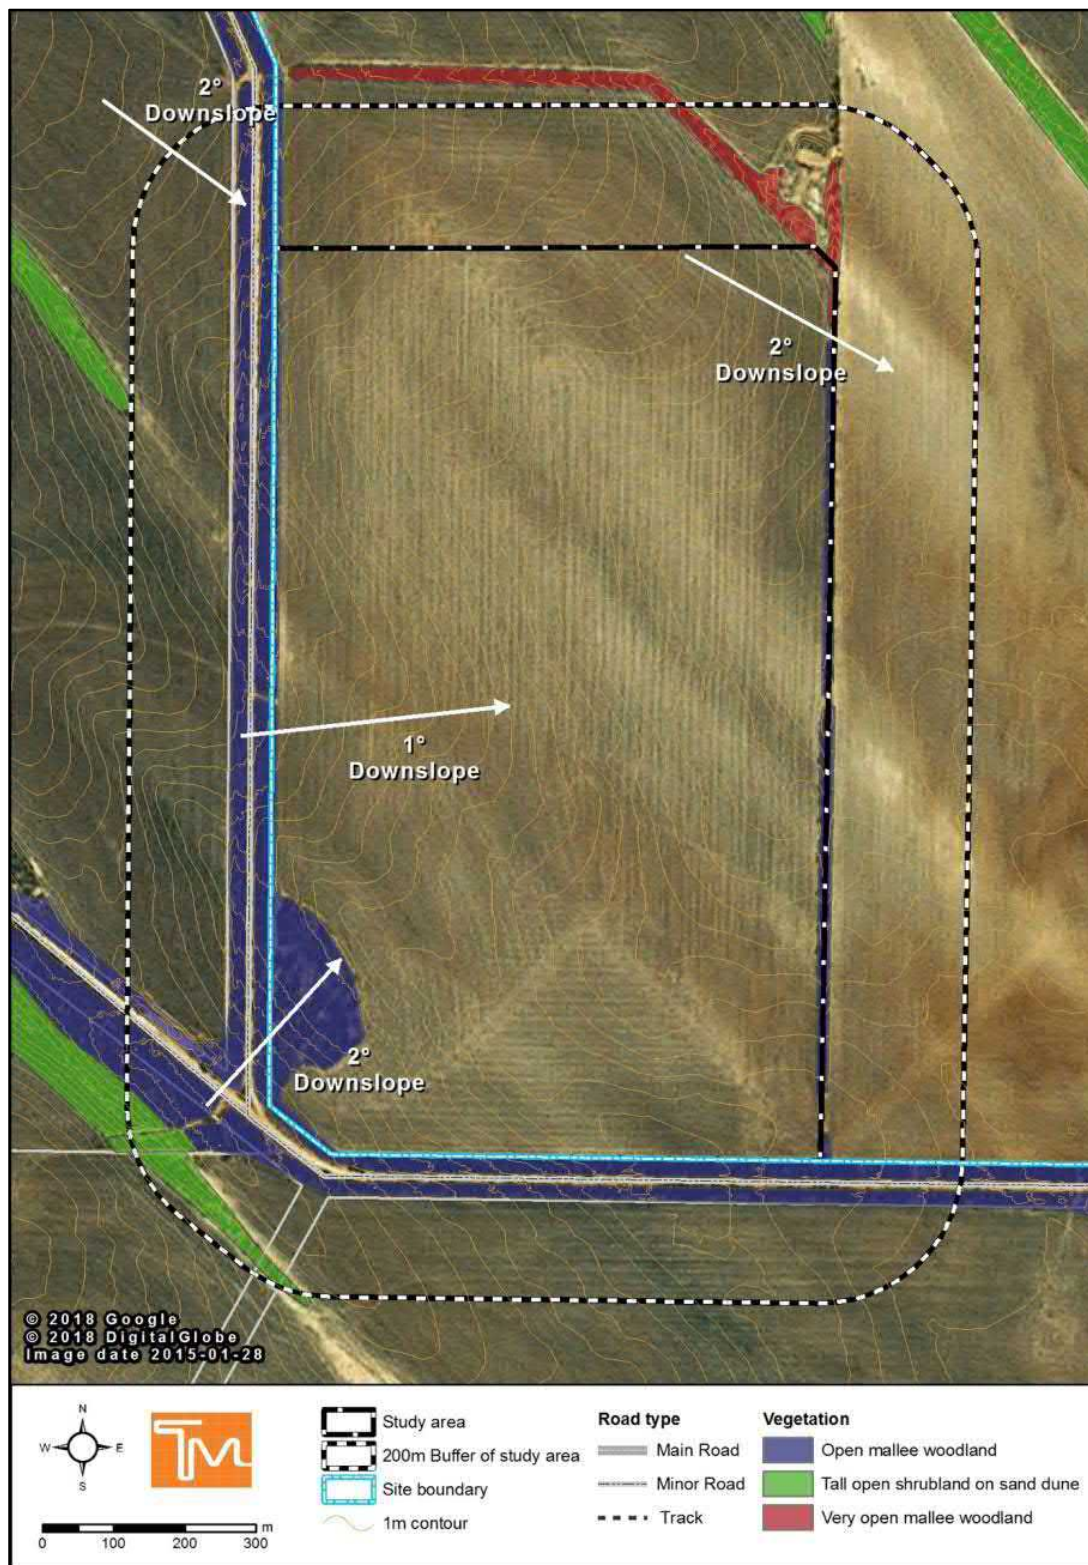
Figure 10 Napandee –site assessment zone for bushfire hazard assessment.
